Transforming a Low Income Neighborhood into a Climate Resilient Neighborhood in Zhenjiang, China

Dr. Nian She

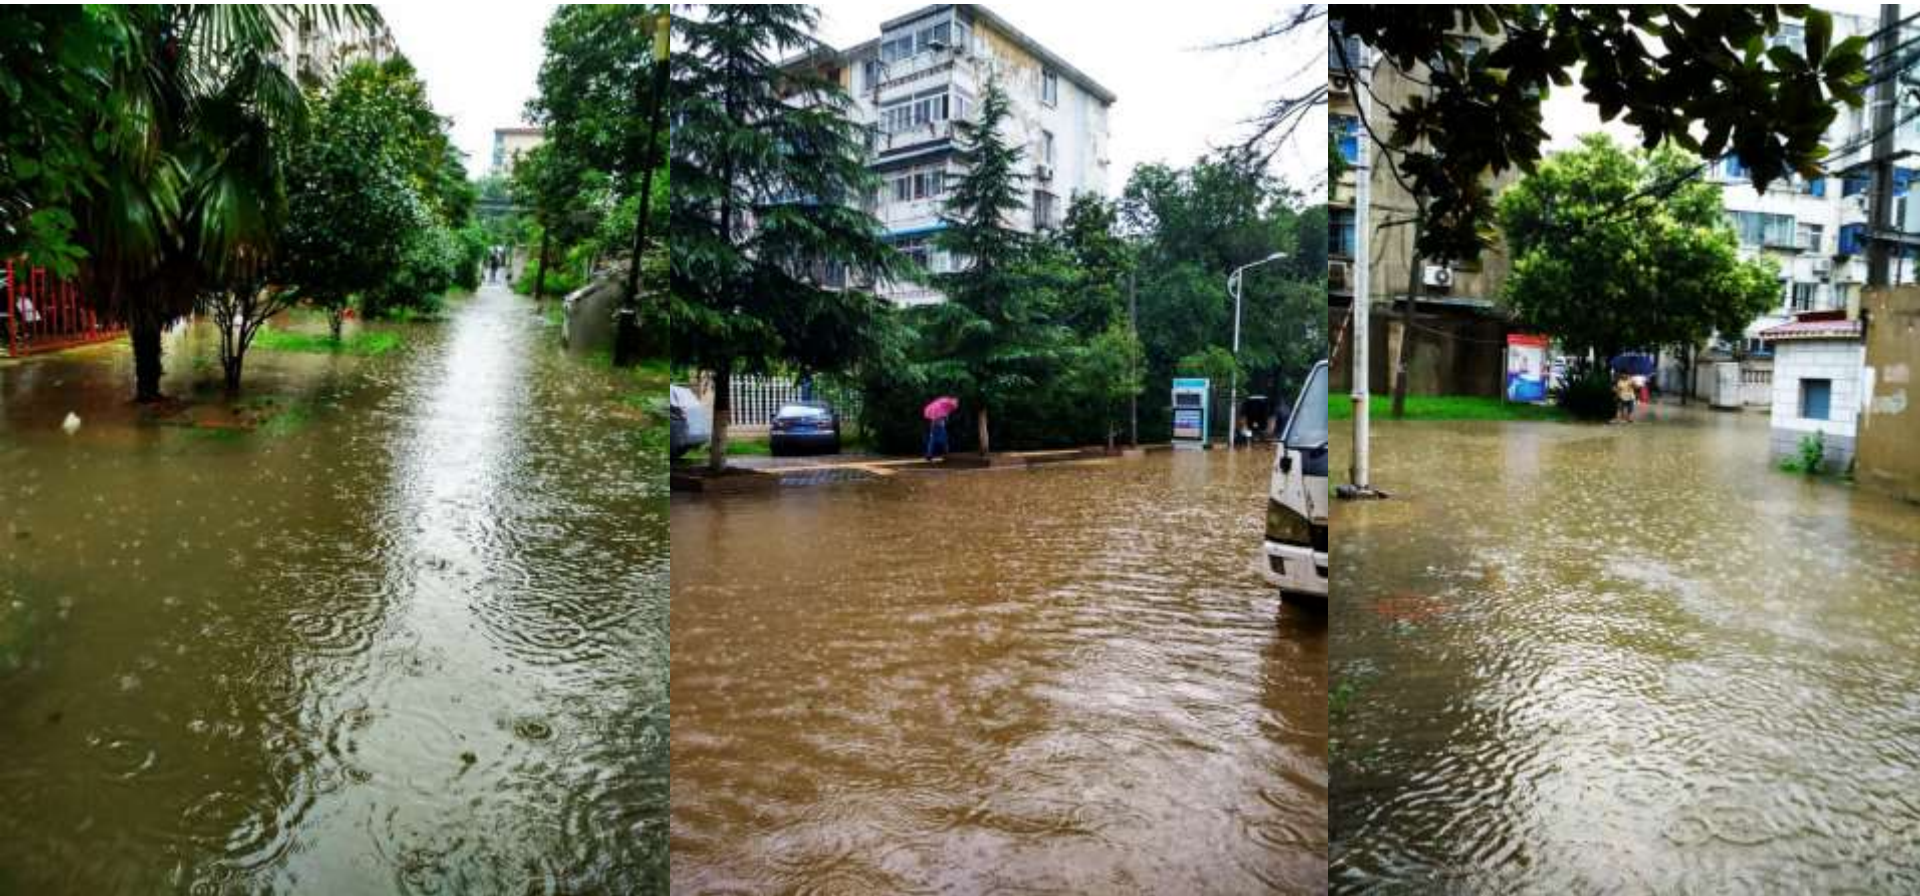
This is a high density neighborhood built in 1970s. Most residents are low income retirees. Due to the lack of maintenance, this neighborhood had endured annual flooding, deterioration of aging infrastructure, lack of appropriate sanitary conditions and no parking lot . Young people moved out

Flooding Event in 2015 before the retrofit

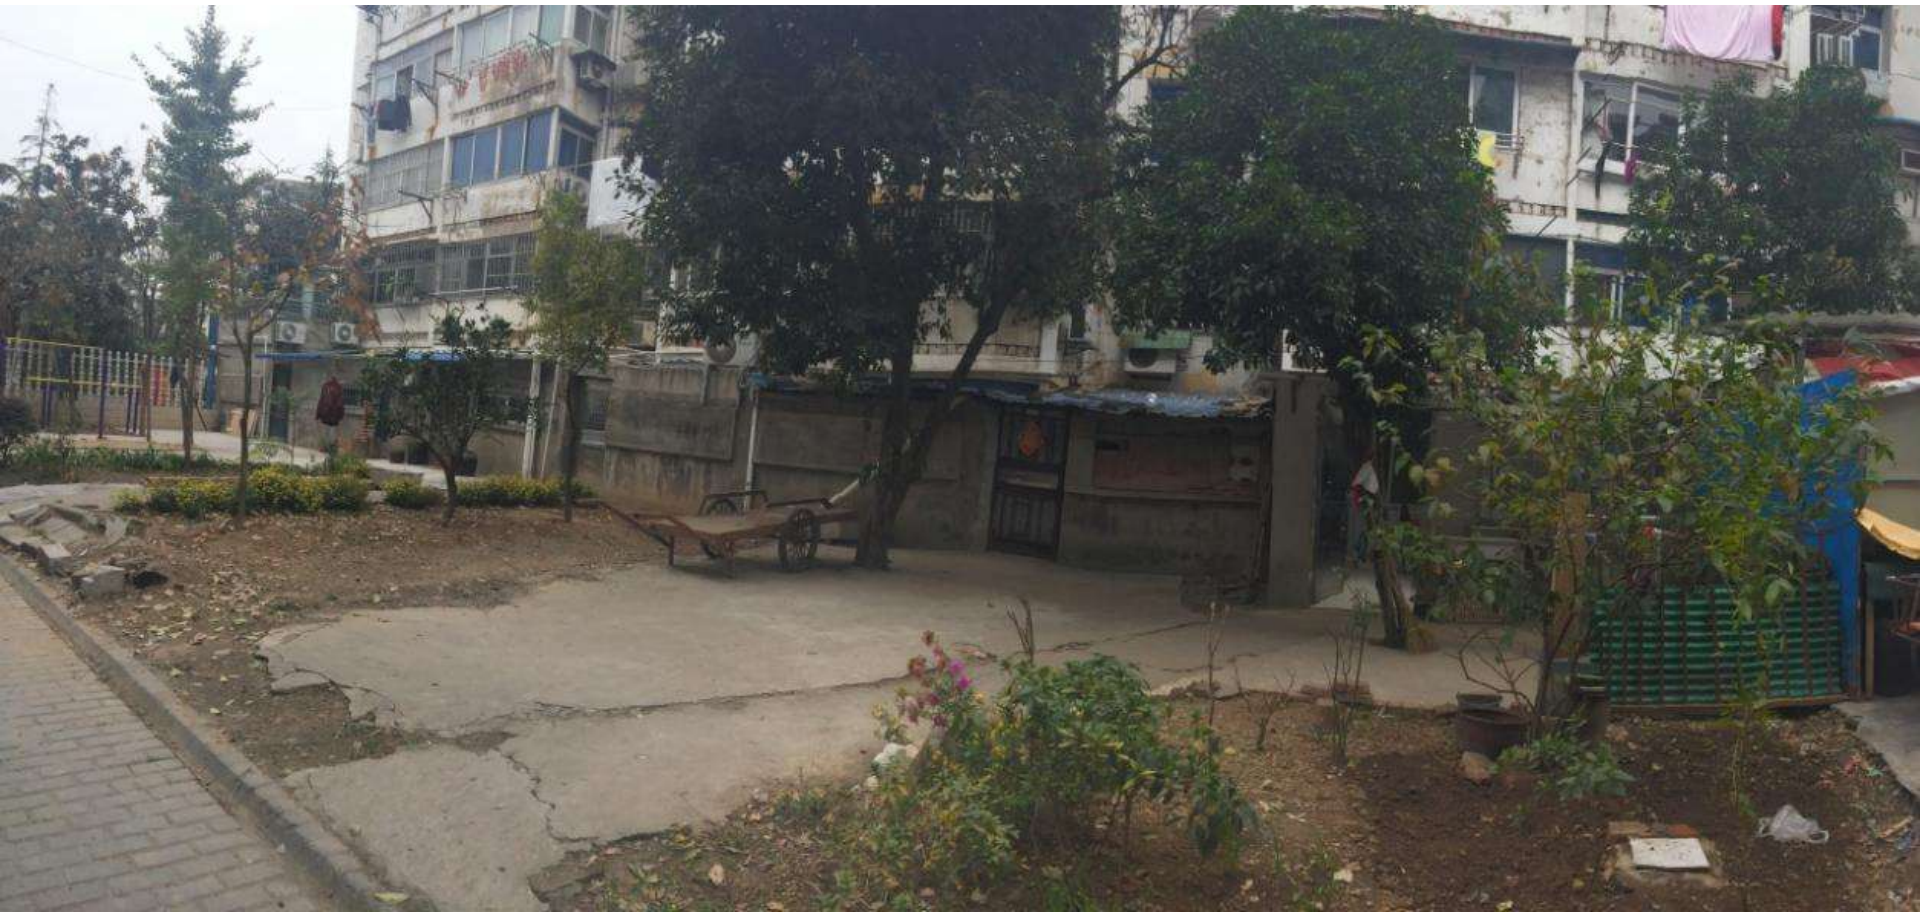
Problem 2 – Pavement Damage

For decades there was no maintenance. The pavements in the neighborhood were damaged. Many green spaces were destroyed

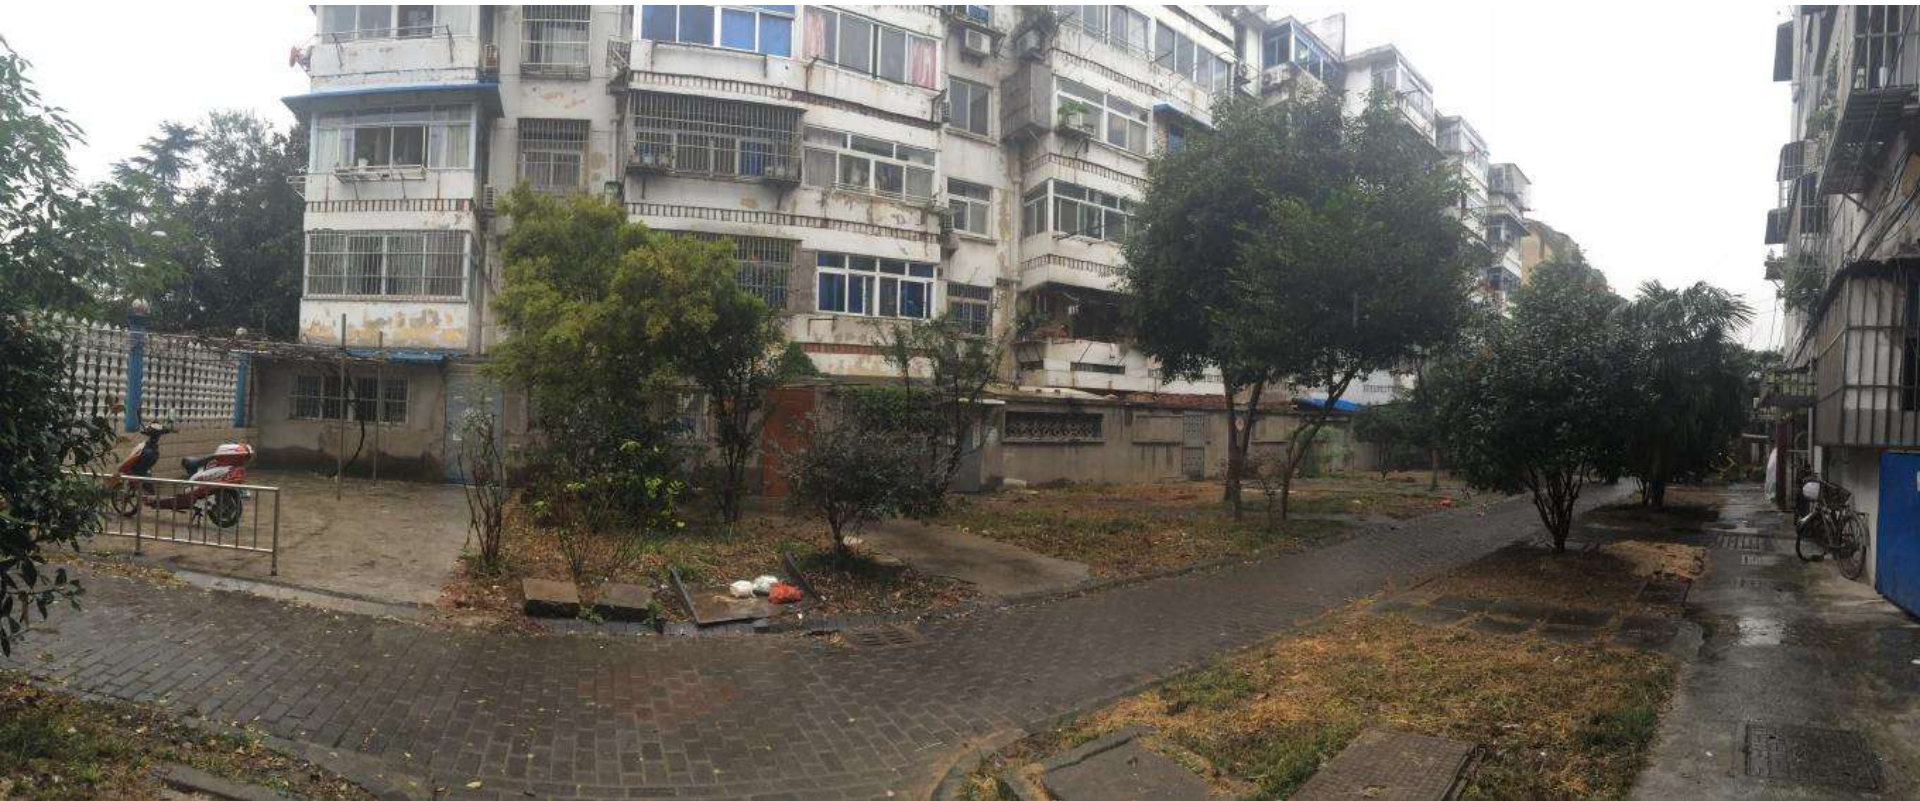
Problem 3 – Landscape Sites Became Garbage Dumping Ground

The garbage were dumped into landscape sites

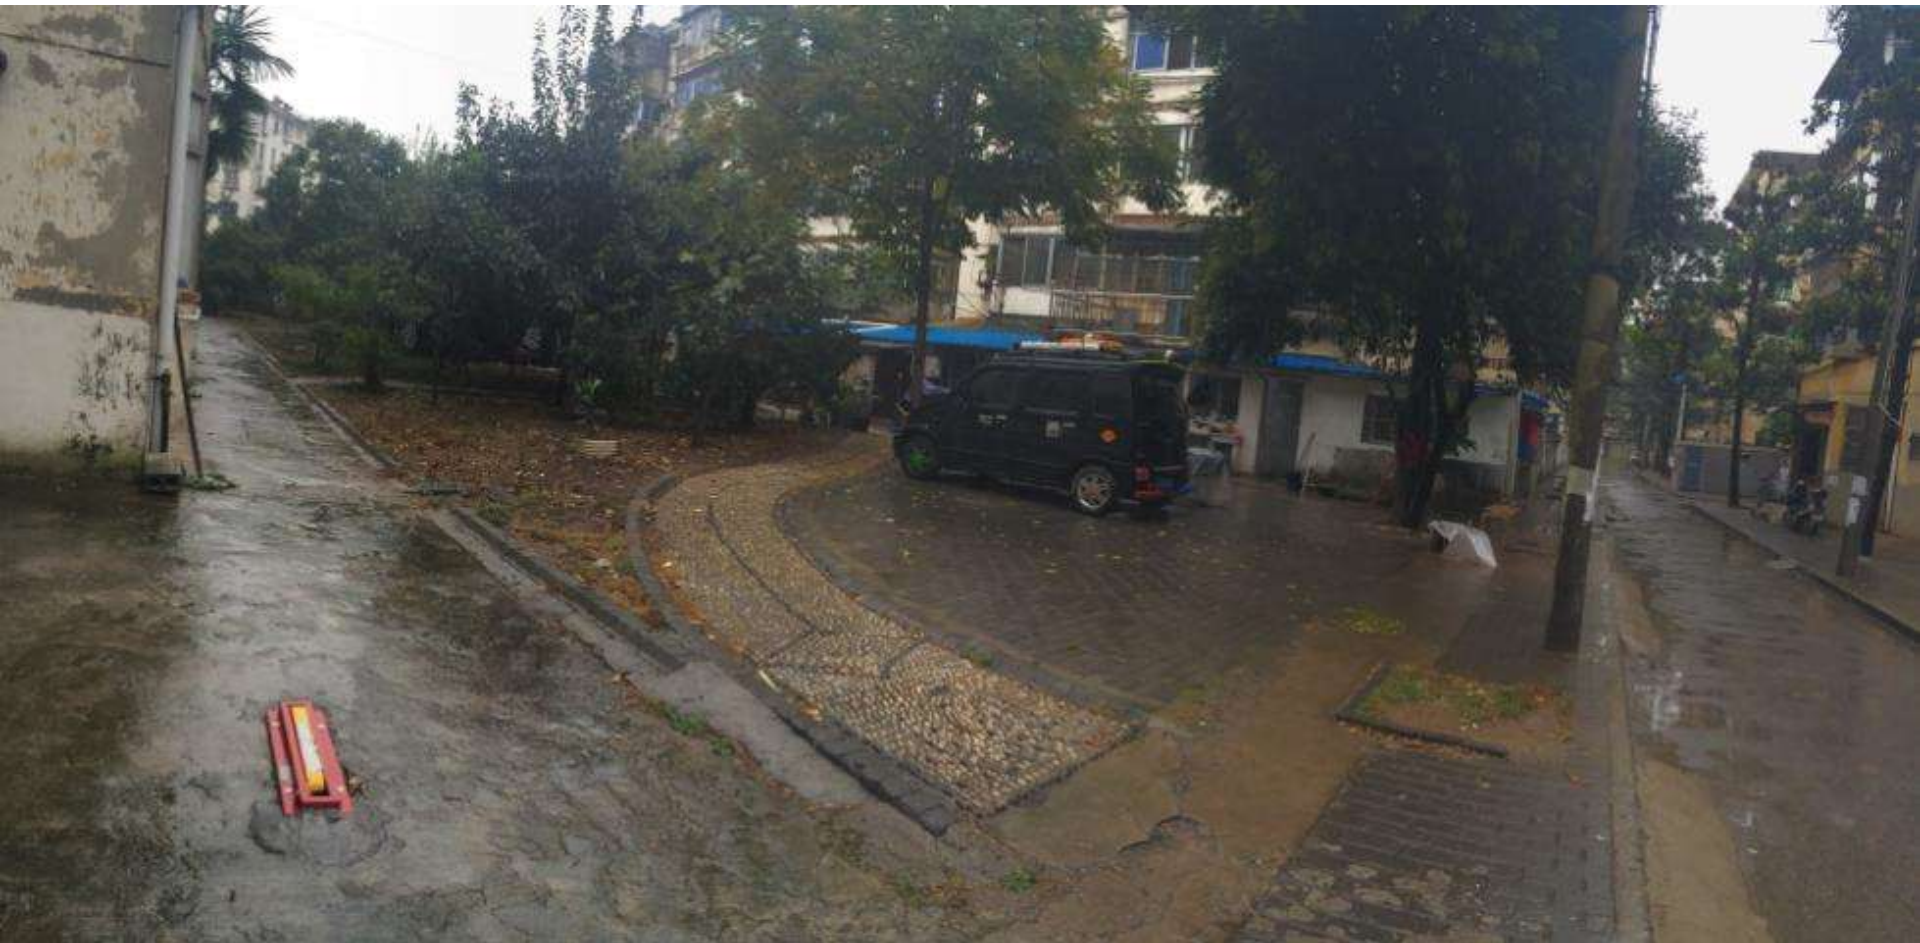
Problem 4 – Lack of Parking Space

Due to lack of parking space some green space became “illegal parking lots”

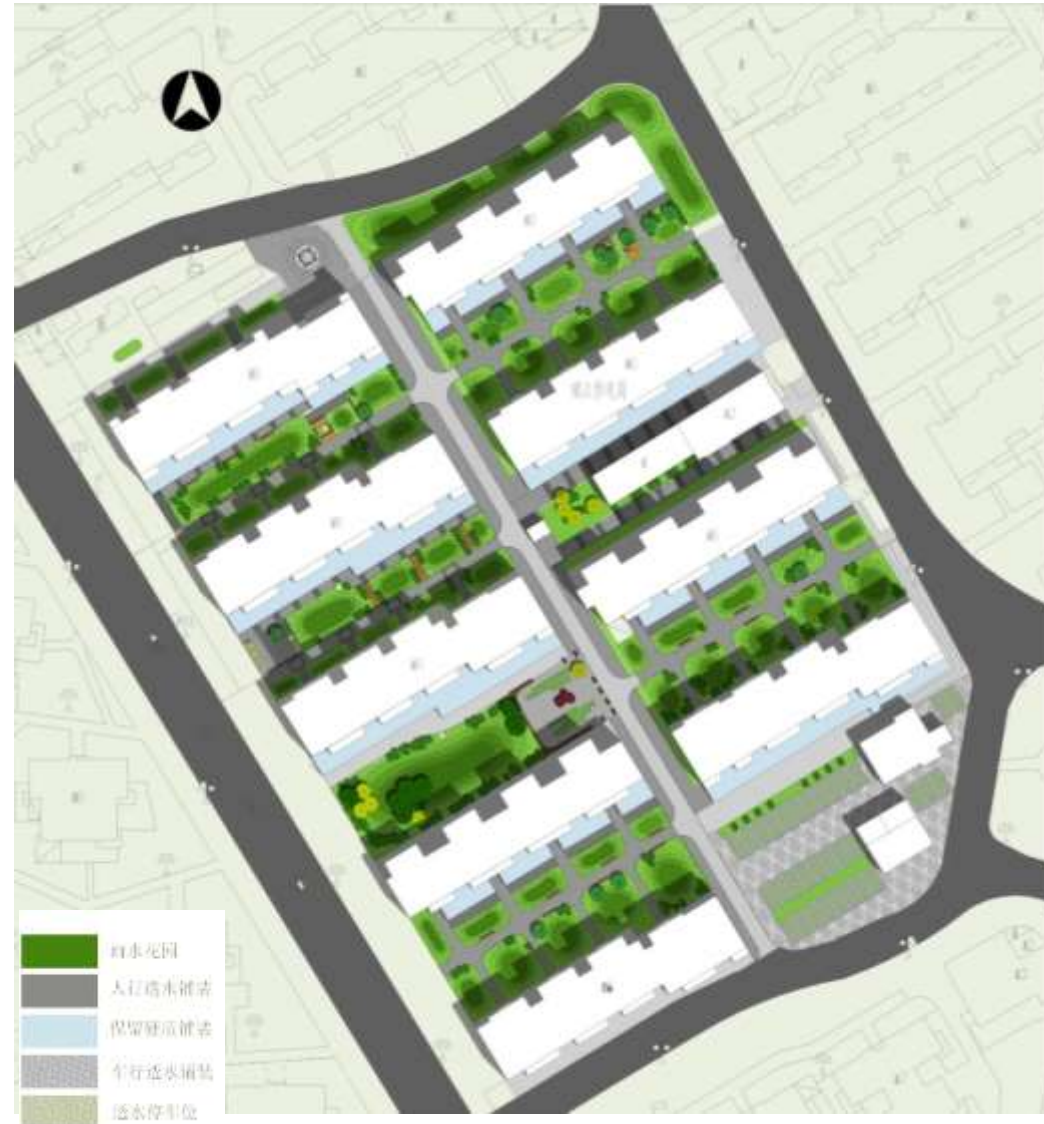
LID design process :

1. Site Investigation
2. Survey drainage network
3. Subcatchment delineation
4. Communication with residents
5. Soil infiltration testing
6. LID layout and modeling
7. Separation
8. Monitoring

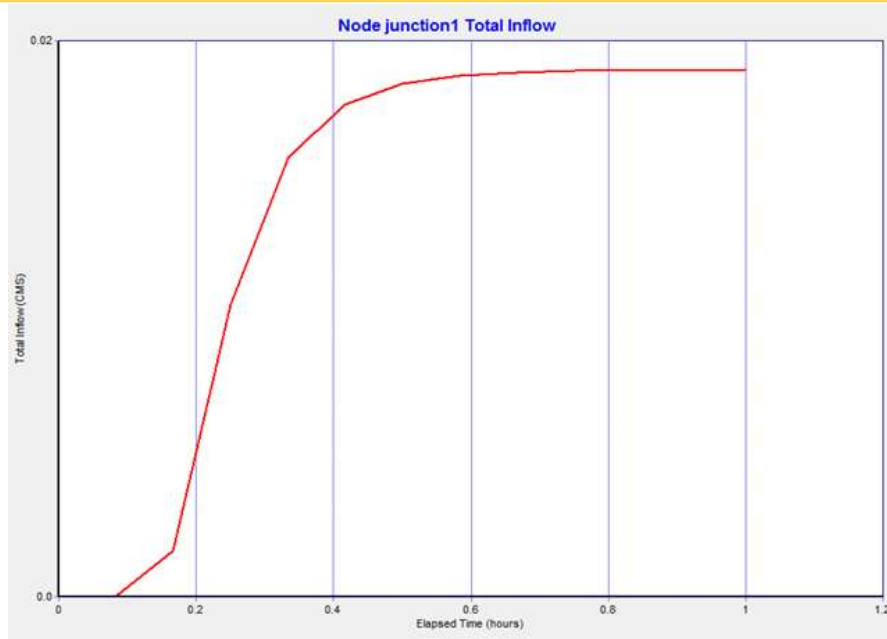
NO-LID (Before) 6.2mm rainfall detention

Concluding :
LID can delay 13 hours
of discharge at the
outfall. (Without LID it
is just 1 hour)

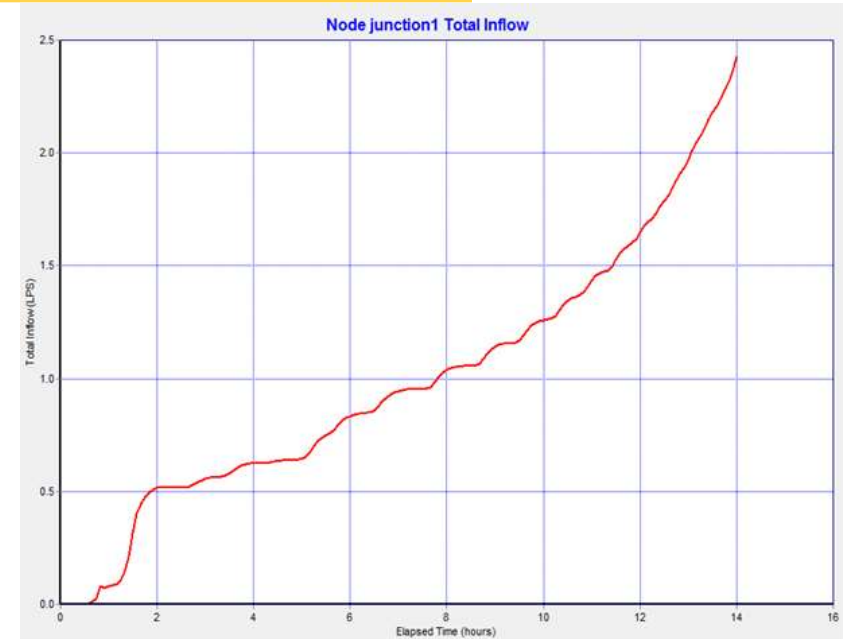
LID (After) 34.6mm rainfall detention

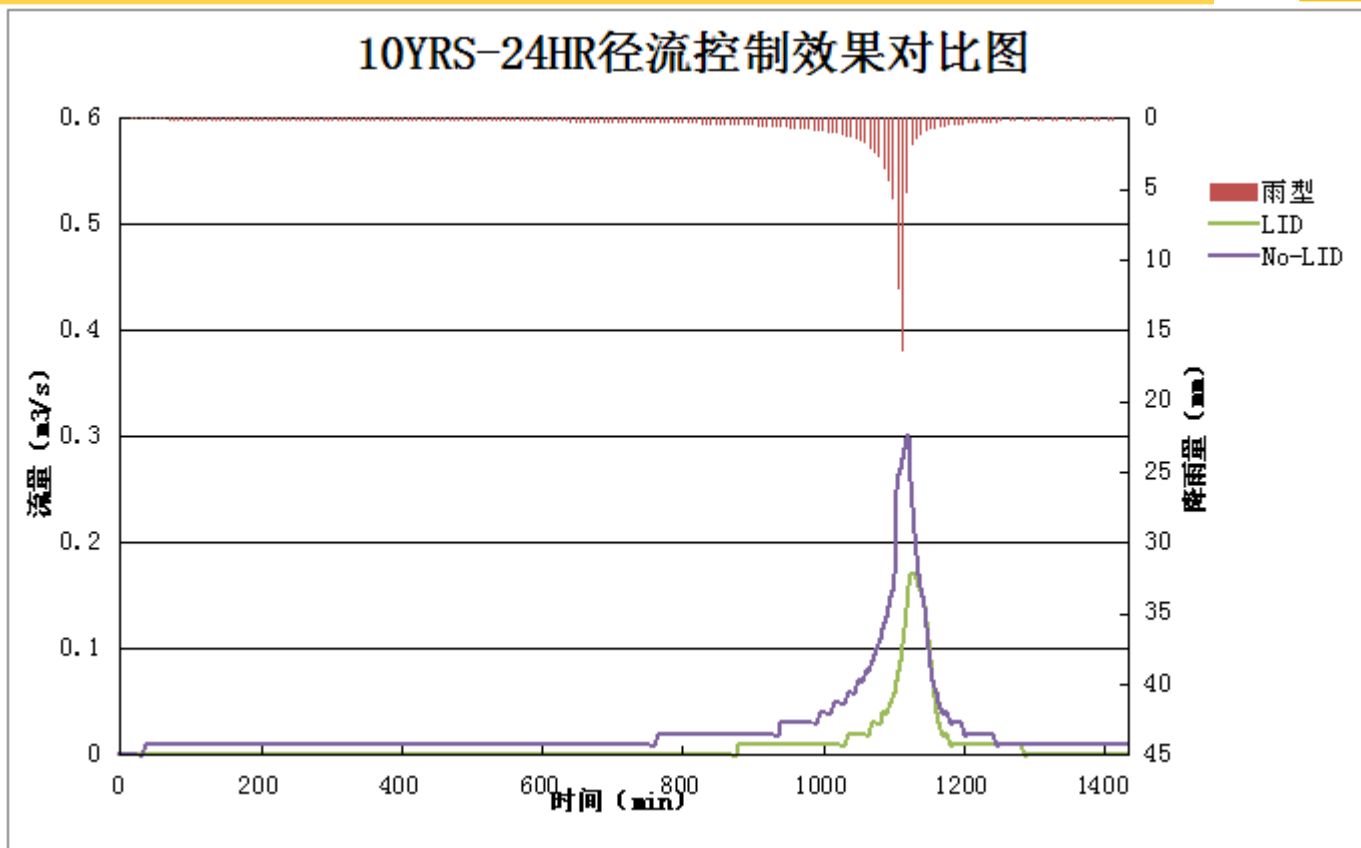
10yr-
24h :

Rainfall (mm)	Rainfall peak (min)	Runoff peak (min)	Runoff Volume (m³)	Runoff peak (m³/s)	Runoff Coefficient
Before	175.0	1115	1120	2810	0.30	0.85
After	175.0	1115	1125	1290	0.17	0.40

Volume Reduction 54% , Peak Reduction 43% , Peak shifting

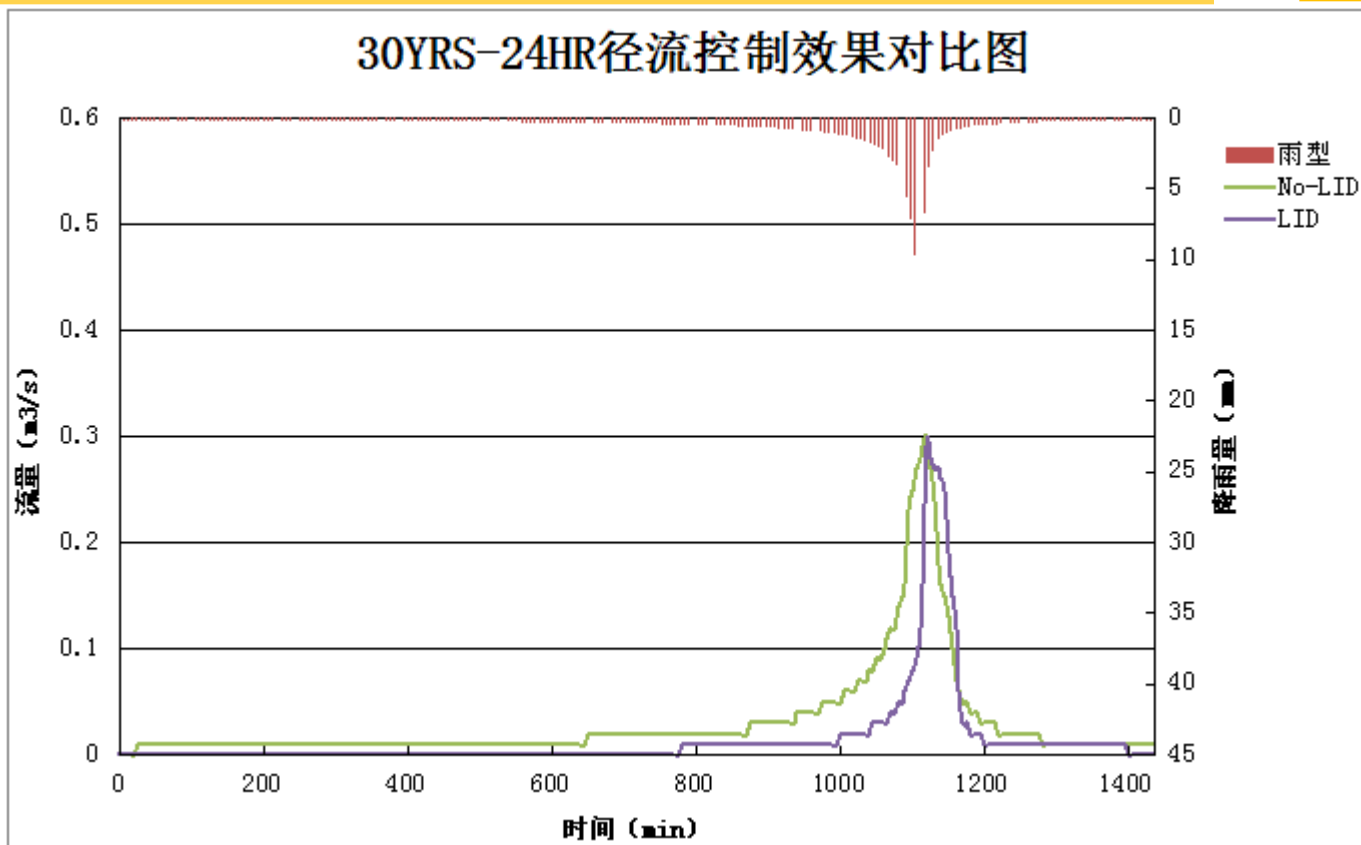
30yr-
24h :

Rainfall (mm)	Rainfall peak (min)	Runoff peak (min)	Runoff volume (m^3)	Runoff peak (m^3/s)	Runoff Coefficient
Before	220.0	1115	1120	3600	0.30	0.87
After	220.0	1115	1125	1890	0.29	0.46

Runoff volume reduction 47.5% , No significant reduction of peak

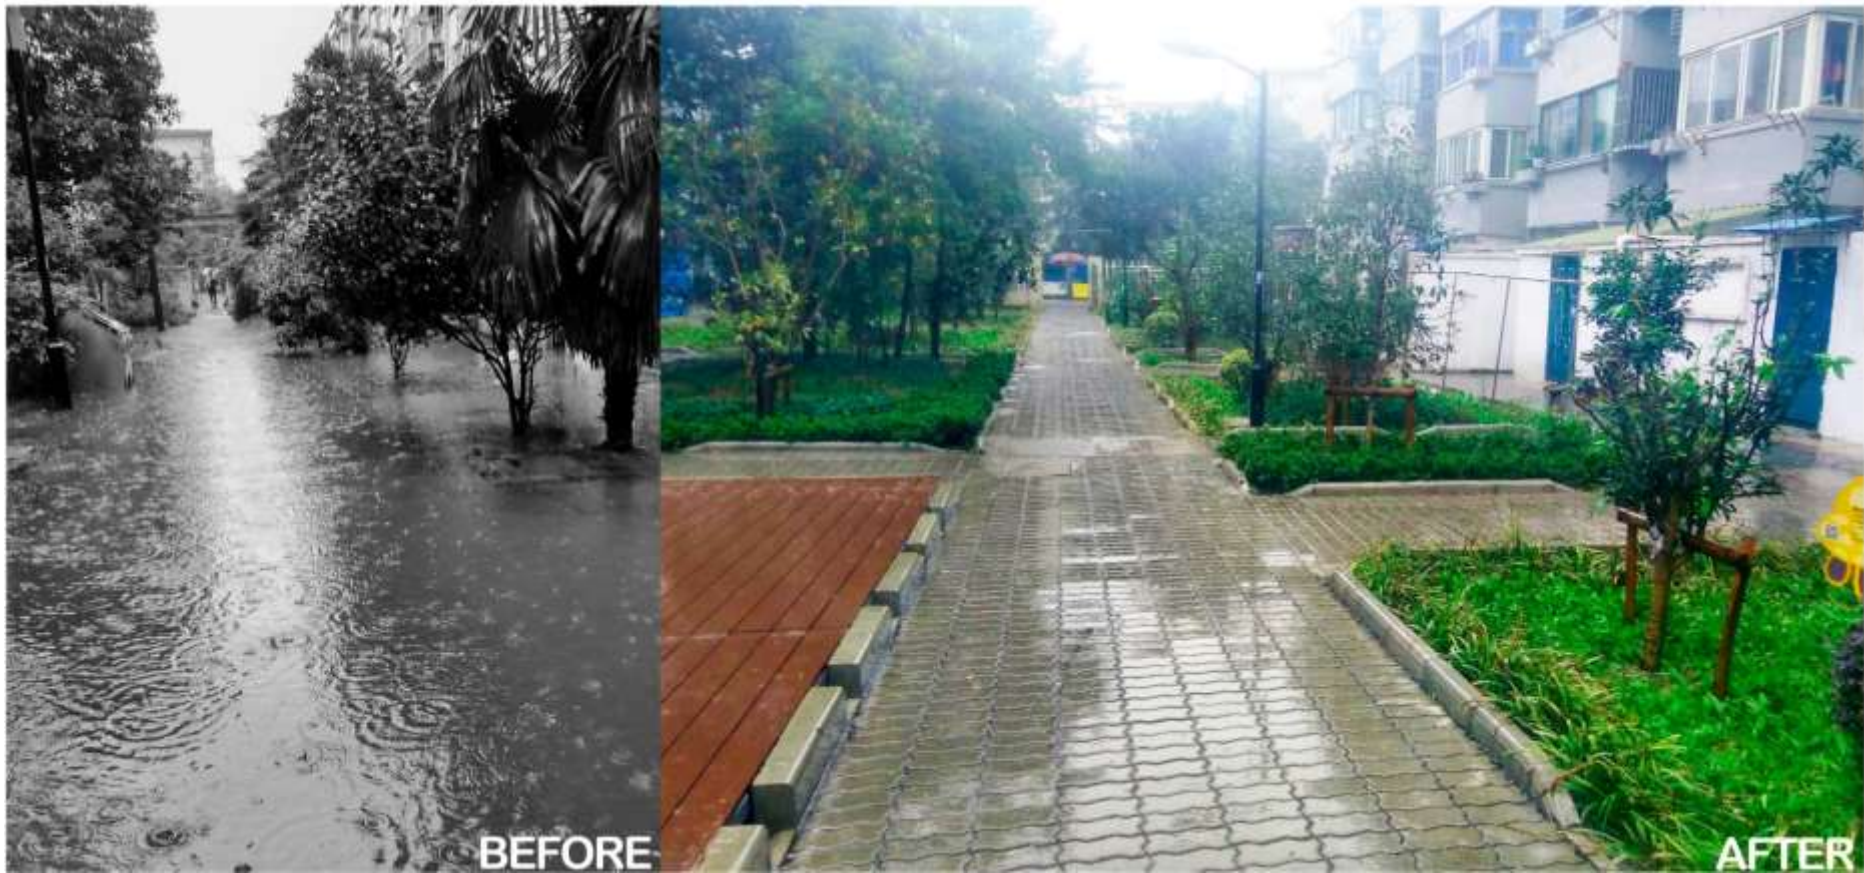
During Heavy Storm

After completion of the project the neighborhood experience two heavy storm events. One is 138 mm rainfall in 2016 and another is 125mm rainfall in 2017.

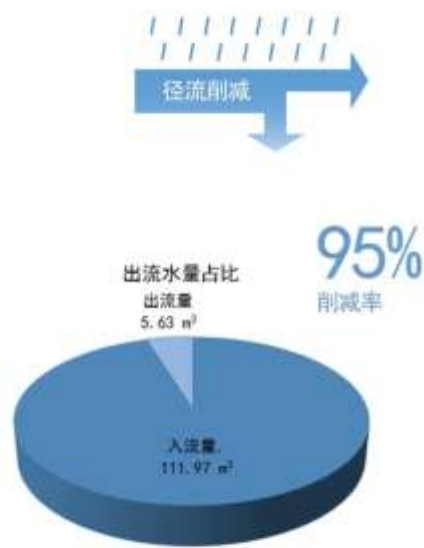
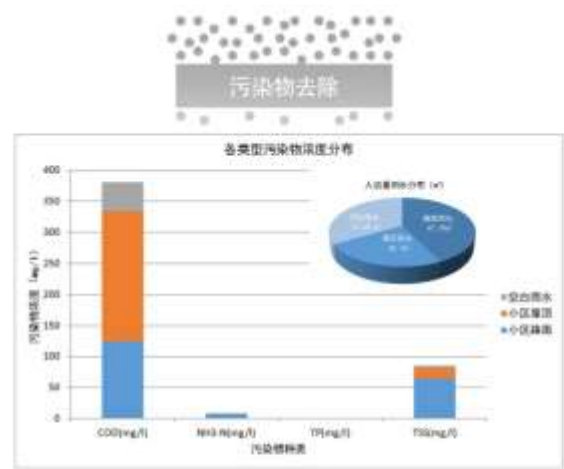
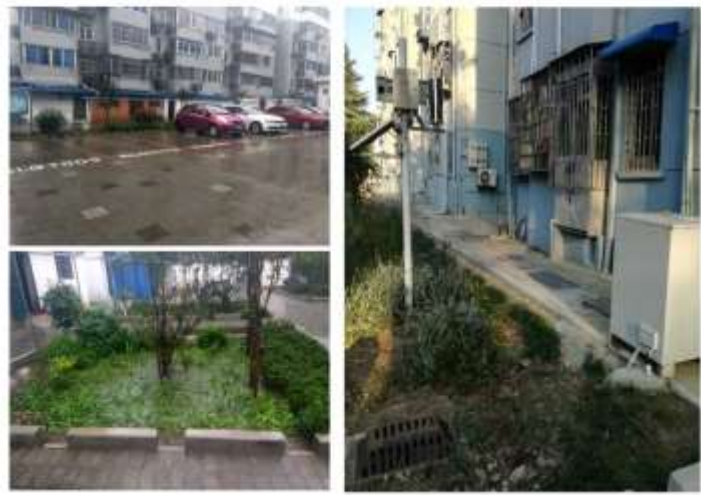
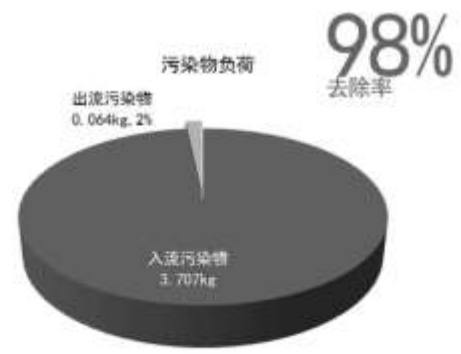
Monitoring Results

下垫面类型	COD (mg/L)	NH ₃ -N (mg/L)	TP (mg/L)	TSS (mg/L)	人口量 (人)
小区道路	125.88	5.37	0.21	94.71	47.78
小区绿地	289.48	0.38	0.01	16.58	26.7
空白雨水	46.27	0.25	0	4.73	37.49
综合平均值	118.82	3.37	0.11	33.11	111.97

指标名称	浓度 (mg/L)	人口量 (人)
综合平均值	23.11	111.97
空白雨水	11.38	37.49
小区道路	5.63	47.78
小区绿地	0.04	26.7

95% Flow Reduction, and 98% TSS Removal

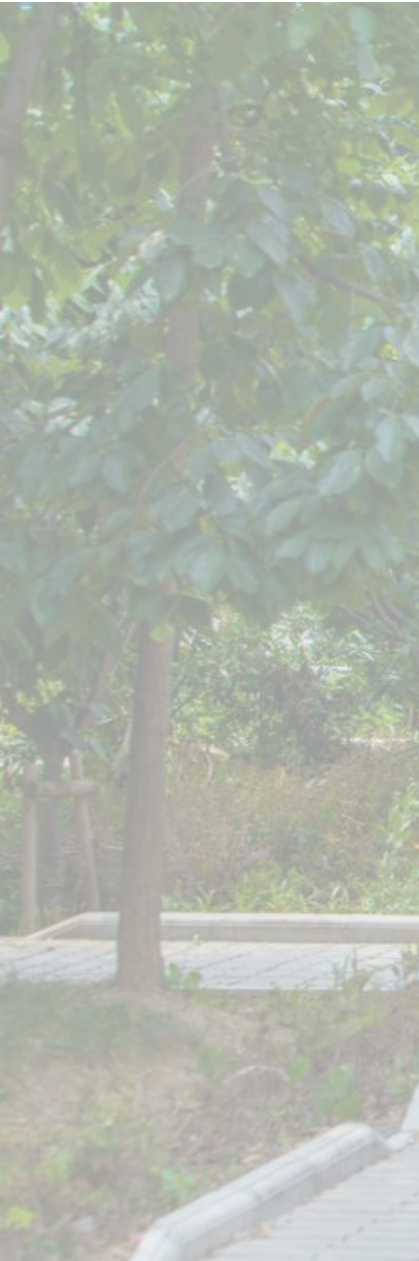
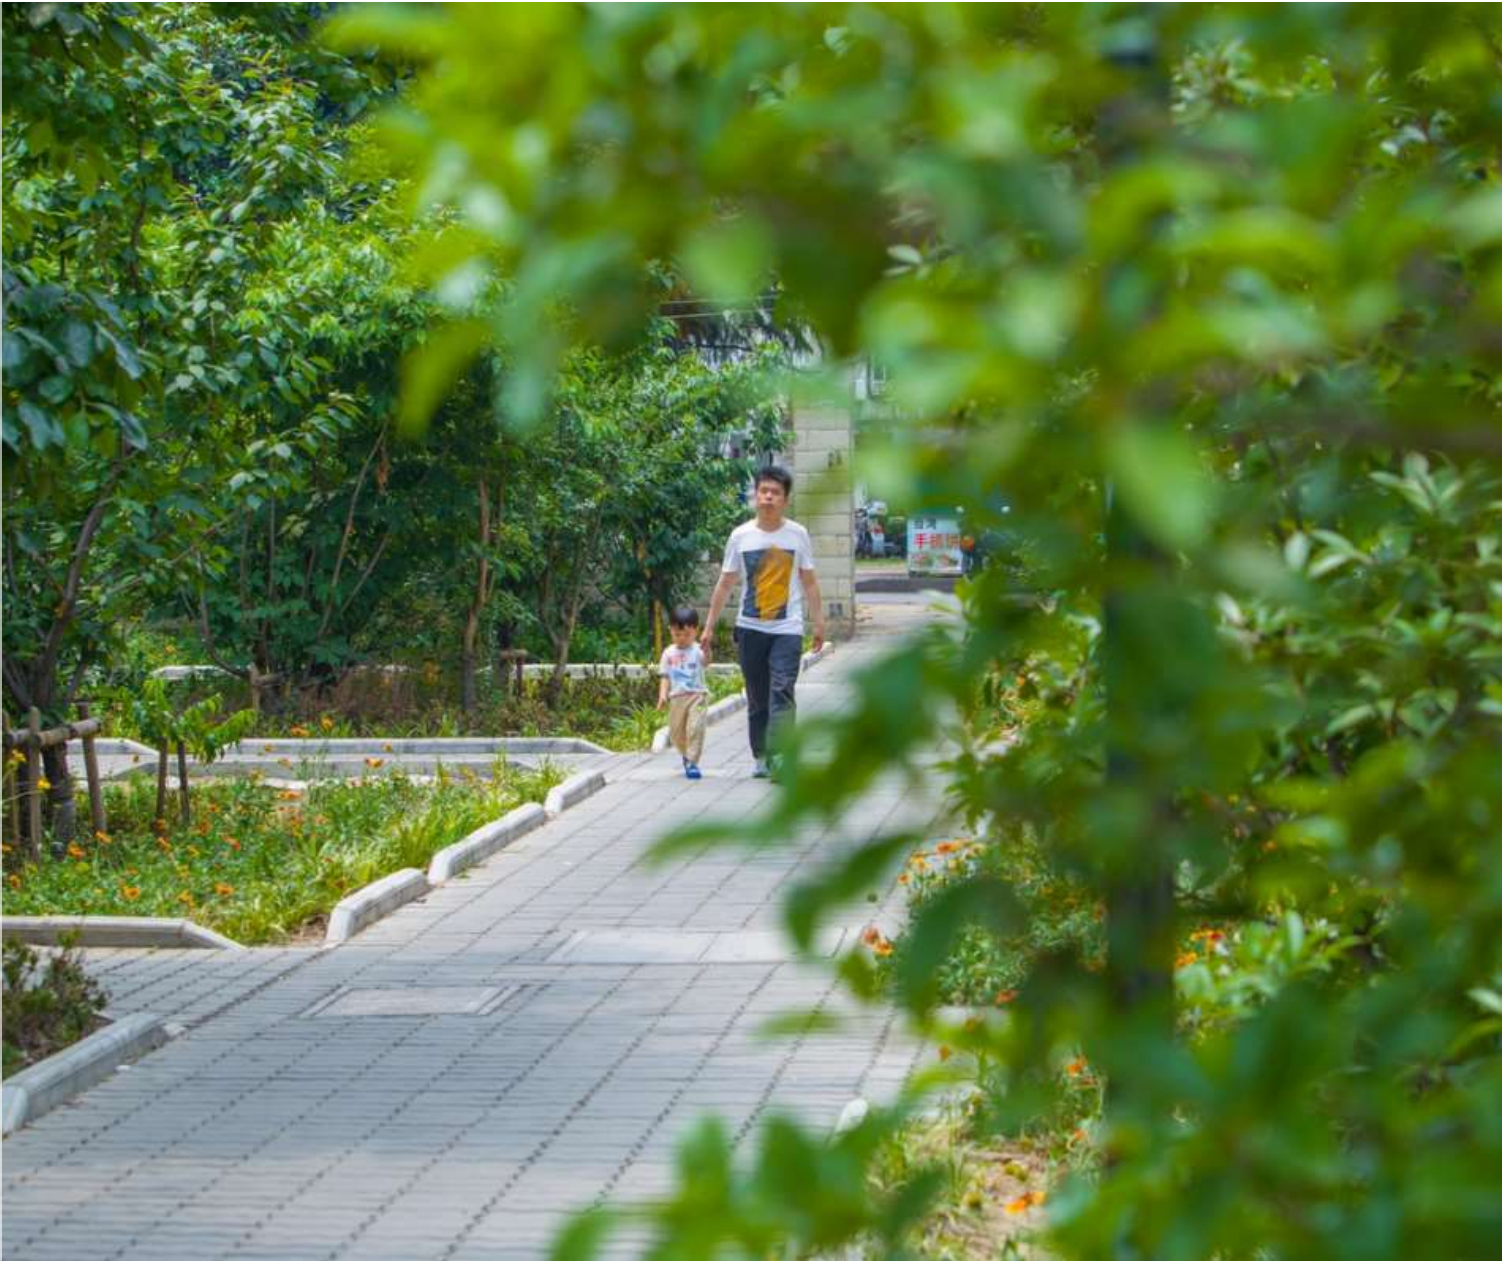
Rain Garden + Porous Access = Improved Personal Safety
