Heritage compatible and cost saving restoration of a historical railway viaduct

A. Gerdes, Scientific Director, KIT Innovation Hub Prevention in Construction

Laufenmühlen-Viaduct

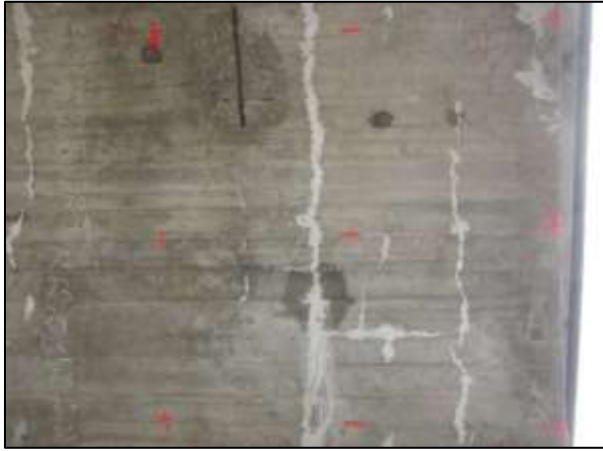
Cracks

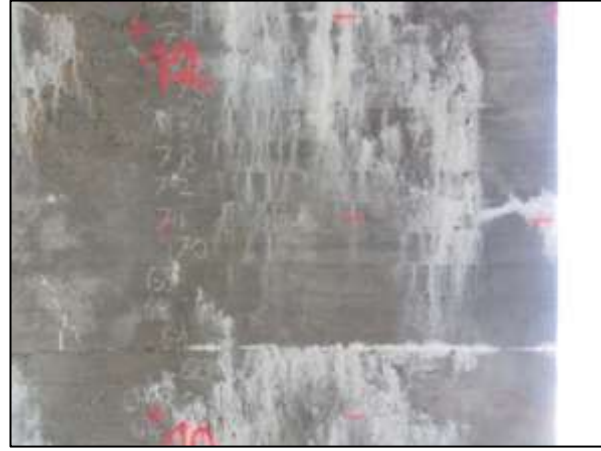
Efflorescences

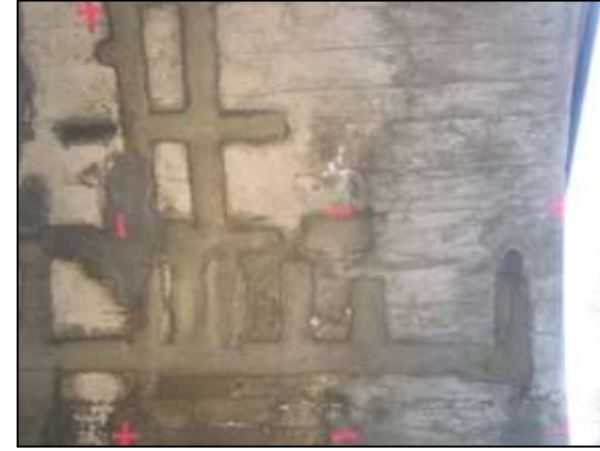
Old repair patches

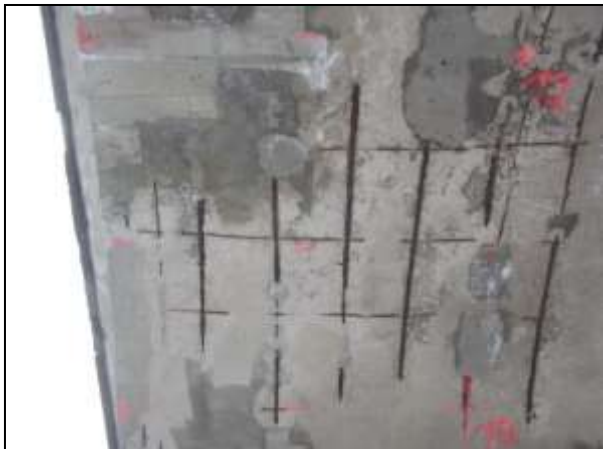
Corroding reinforcement

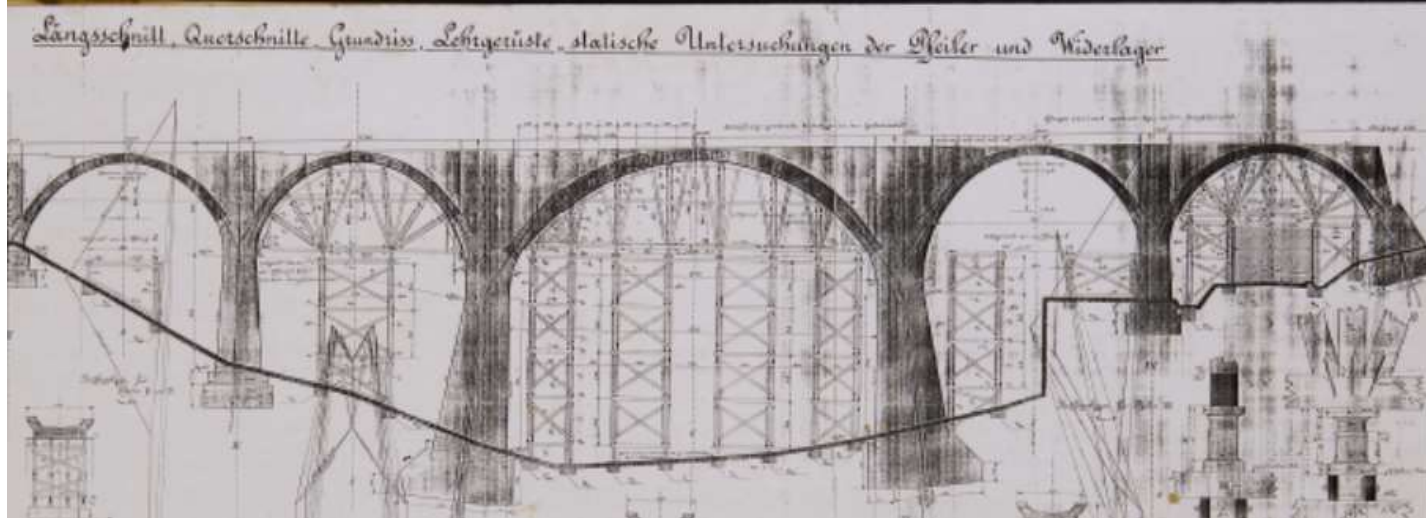
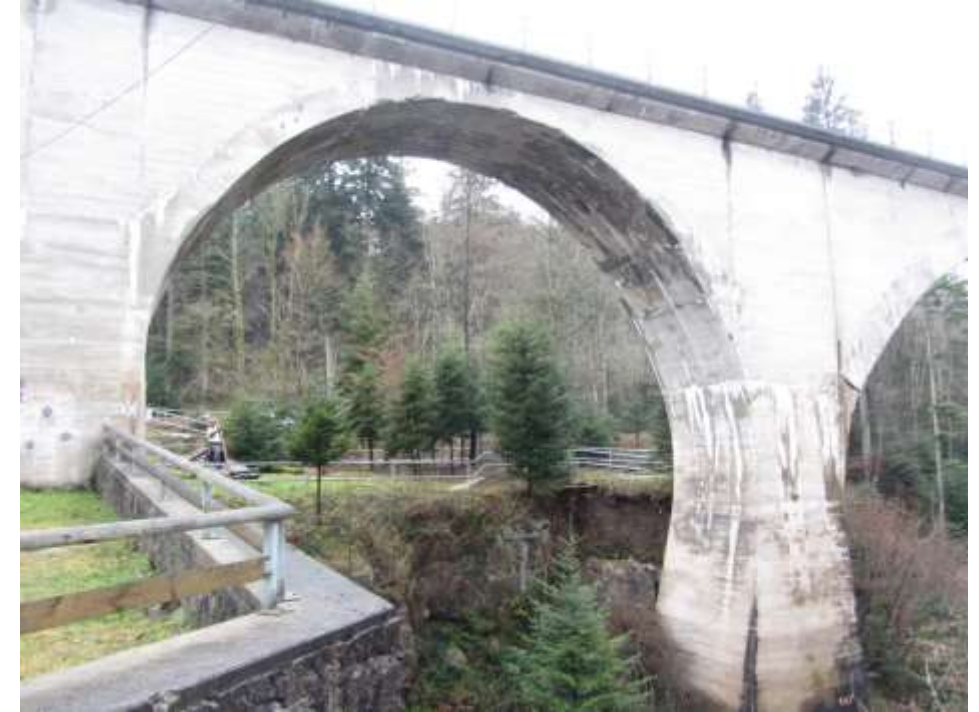
Original repair concept based on simplified construction analysis

- Determination of the compressive strength of drill cores → very low values (static calculations: - 2.5 N/mm²)
- Suspension of railway operation
- Production of new concrete-made bridge arches made to support the old arches
- In this case the Laufenmühlen Viaduct will no longer be a monument
- Calculates repair costs: 3.2 Mio. €

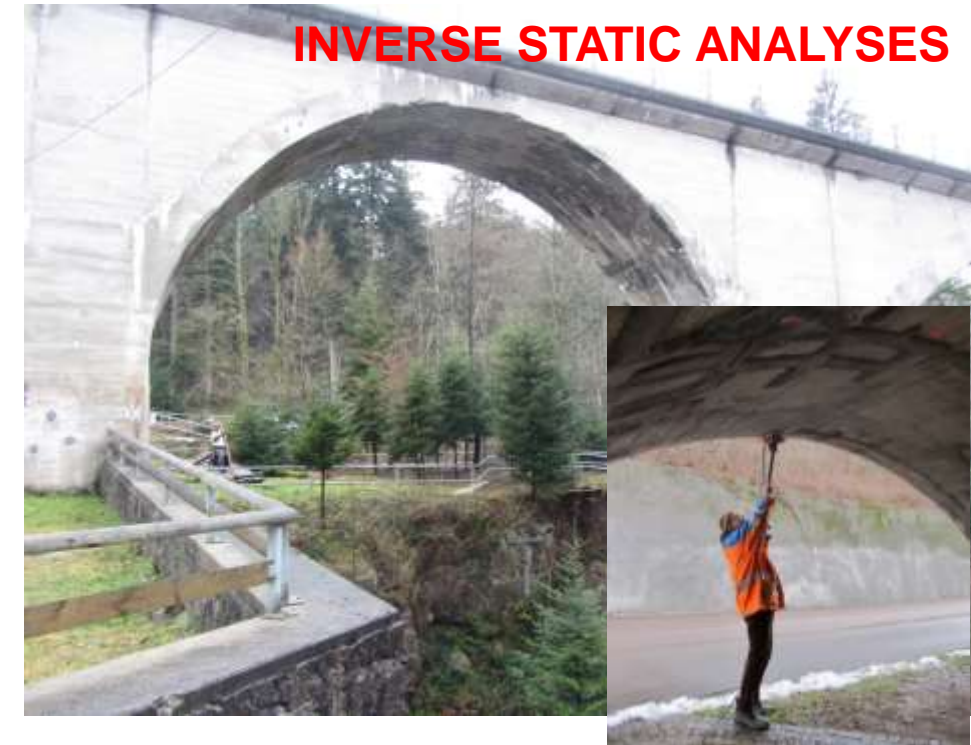
CONCEPT FOR THE INVESTIGATION OF THE LAUFENMÜHLEN VIADUCT

- Detailed survey of visible damage
- Radar examination of the arches
- Material investigations on drill cores taken from the arches
- Comparison of the test results as a basis for the repair concept
- Evaluation of repair methods
 - technical aspects
 - costs
 - compatibility for the environment and monument character
